FIELD STUDY

75W-90 Long Life Synthetic Gear Lube Study in Over-the-Road Applications

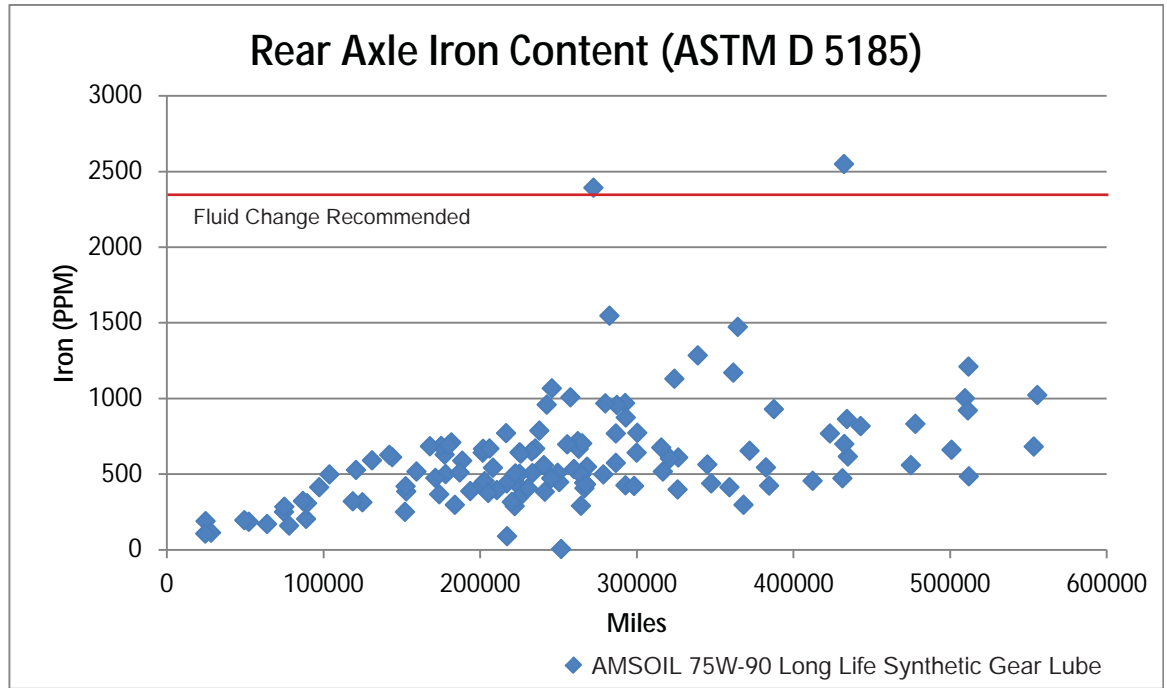
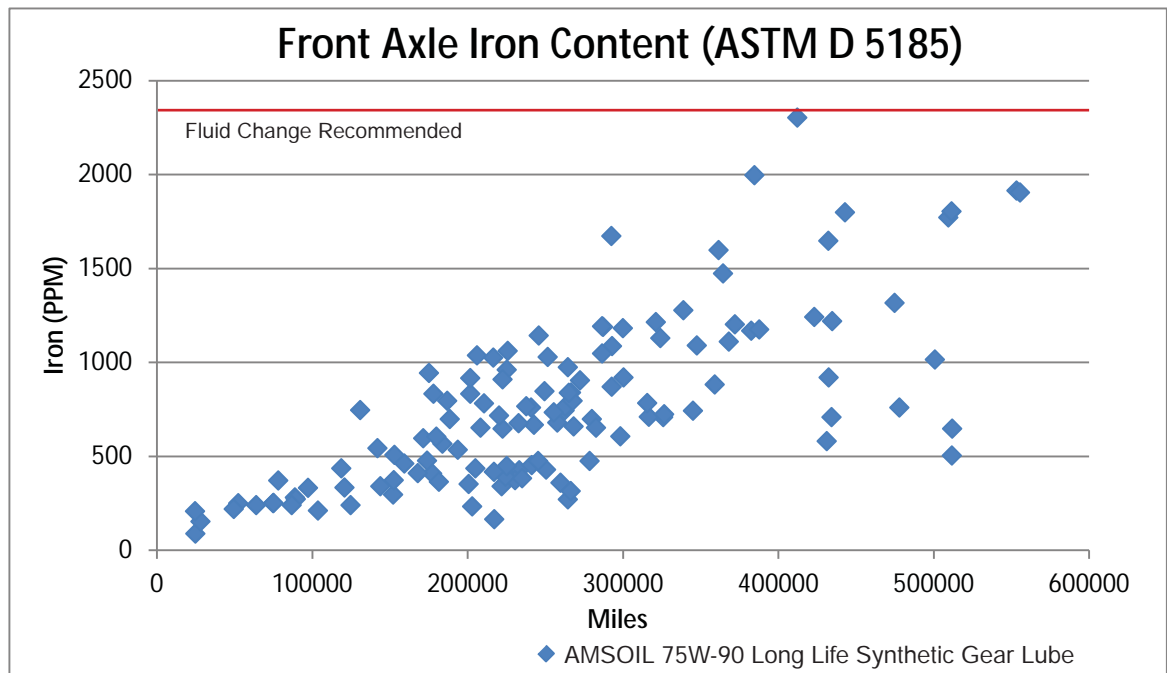
Oil Analysis – Iron Content

The ability of the lubricant to control iron wear metal generation is especially important in the front differential because it is engaged constantly, increasing stress. AMSOIL 75W-90 Long Life Synthetic Gear Lube limited iron to levels below the level at which a fluid change is recommended in the front differential in all instances, demonstrating strong wear protection. Protection in the rear differential was equally as high, with nearly all samples measuring below the threshold.

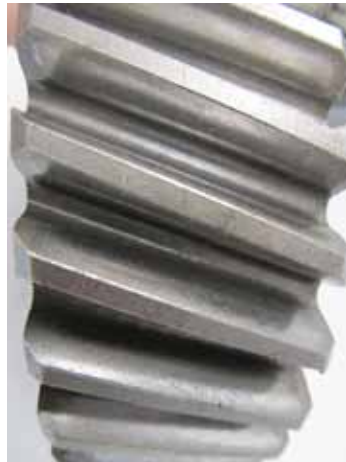
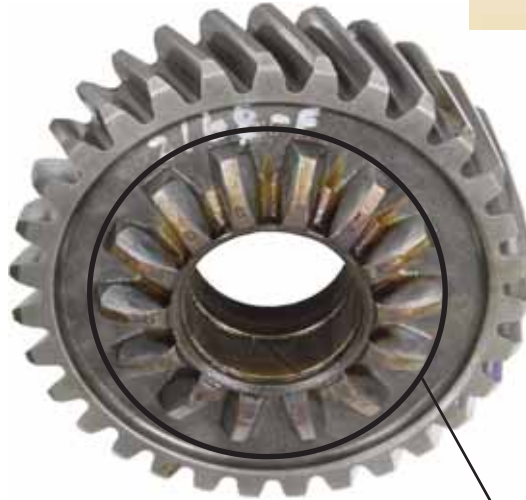
Front Axle Helical Gears & Thrust Washer

Condition	Helical Drive Gear	Helical Driven Gear	Side Gear	Output Shaft Side Gear	Thrust Washer
Burnish	Medium Bright	Bright	Bright	Bright	NR
Wear	7	7	6	7	7
Sludge	6	8	6	7	6
Ridging	NR	8	NR	NR	NR
Rippling	NR	9	NR	NR	NR
Pitting	8	NR	7	7	7
Spalling	NR	NR	7	9	NR
Discoloration	NR	NR	NR	NR	8

The front axle helical gears are engaged by the driver to connect the front and rear axles when added traction is needed. The design of helical gears allows them to bear increased loads and operate more quietly than other gear designs; however, increased loads also invite increased distress. AMSOIL 75W-90 Long Life Synthetic Gear Lube limited wear to both the helical drive gear and helical driven gear to a *light* level. The lubricant also inhibited burnish, ridging and pitting effectively. The side gear, located on the front of the helical driven gear, and the output shaft side gear also demonstrated a high level of protection.

By nature, the angular cut of helical gear teeth causes the gears to move outward during operation. The thrust washer absorbs the motion, creating wear conditions. AMSOIL 75W-90 Long Life Synthetic Gear Lube controlled wear to a *light* level, confirming the level of protection the lubricant provided.

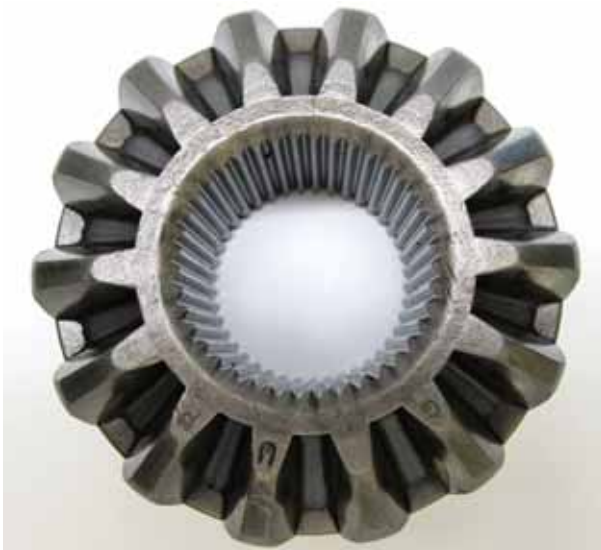
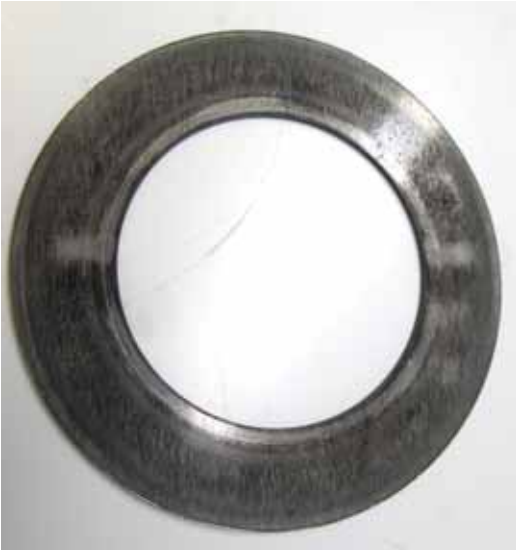
Front Axle Side Gear & Thrust Washer

Condition	Side Gear	Thrust Washer
Burnish	Medium Bright	NR
Wear	7	8
Rippling	10	NR
Ridging	10	NR
Pitting	10	NR
Spalling	10	NR
Scoring	10	NR
Discoloration	9	9
Corrosion	10	NR

The front axle side gear earned perfect 10 merit ratings in six of eight applicable categories, while wear was effectively inhibited to a *light* level, confirming the lubricant excelled in limiting metal-to-metal contact between meshing gear teeth. AMSOIL 75W-90 Long Life Synthetic Gear Lube also protected the thrust washer effectively.

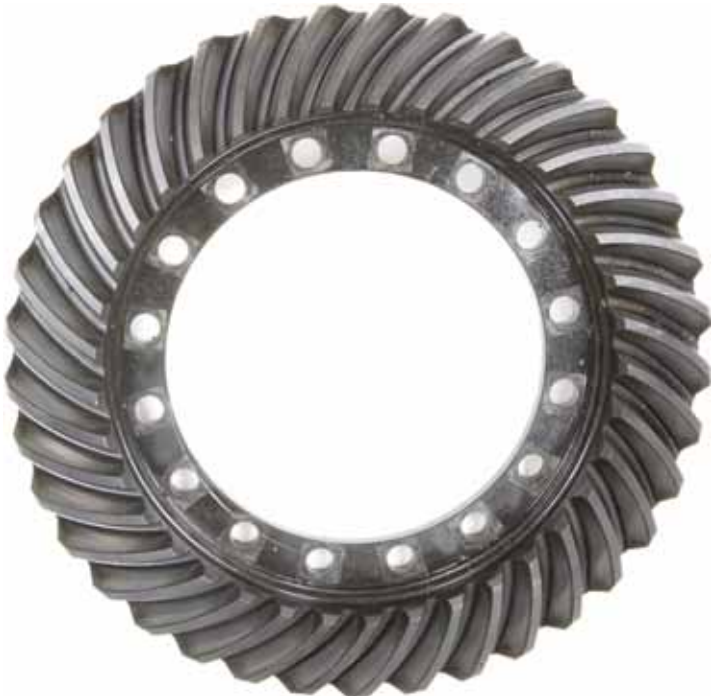
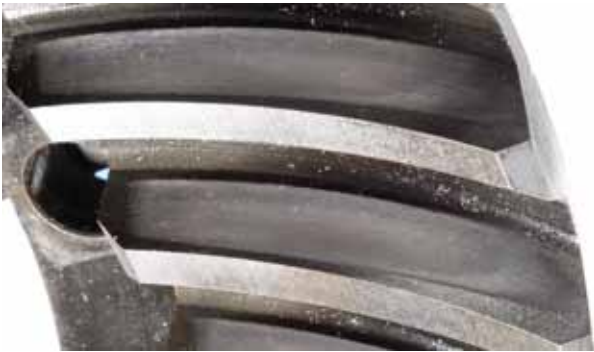
Rear Axle Ring Gear

Condition	Drive Side	Coast Side
Burnish	Dull	Dull
Wear	9	9
Rippling	10	10
Ridging	10	10
Pitting	10	10
Spalling	10	10
Scoring	10	10
Discoloration	9	9
Corrosion	10	10

The rear axle ring gear demonstrated *dull* burnish and earned perfect 10 merit ratings in six of eight applicable categories. The ring gear exhibited only a *trace* level of wear and discoloration despite the increased pressure and shock loading encountered when the rear differential is engaged. AMSOIL 75W-90 Long Life Synthetic Gear Lube provided excellent protection.

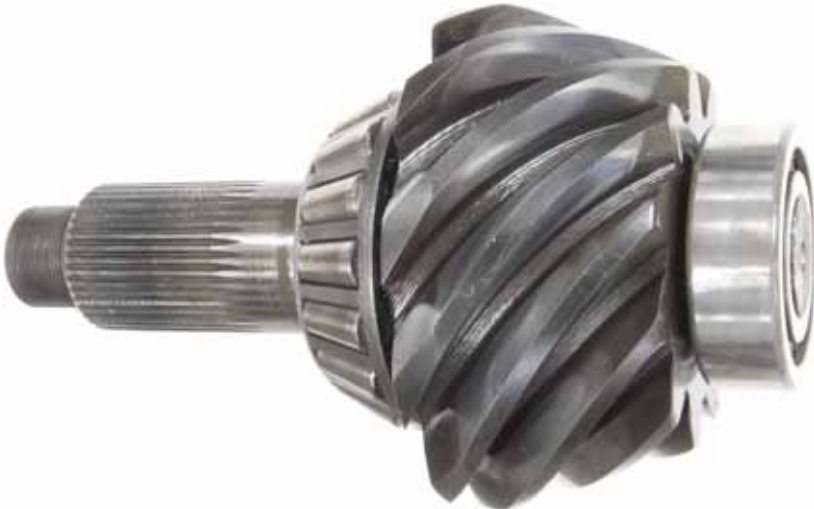
Rear Axle Pinion Gear

Condition	Drive Side	Coast Side
Burnish	Medium Bright	Medium Bright
Wear	8	8
Rippling	9	10
Ridging	10	10
Pitting	10	10
Spalling	10	10
Scoring	10	10
Discoloration	9	9
Corrosion	10	10

The rear axle pinion gear earned perfect 10 merit ratings in most categories, indicating the lubricant developed a strong lubricating film and inhibited distress. The gear ratio (3.36:1) indicates each pinion gear tooth engages in contact 3.36 times more often than each tooth on the mating ring gear. Given these conditions, the *medium bright* burnish rating is high, as is the *trace-light* wear rating.

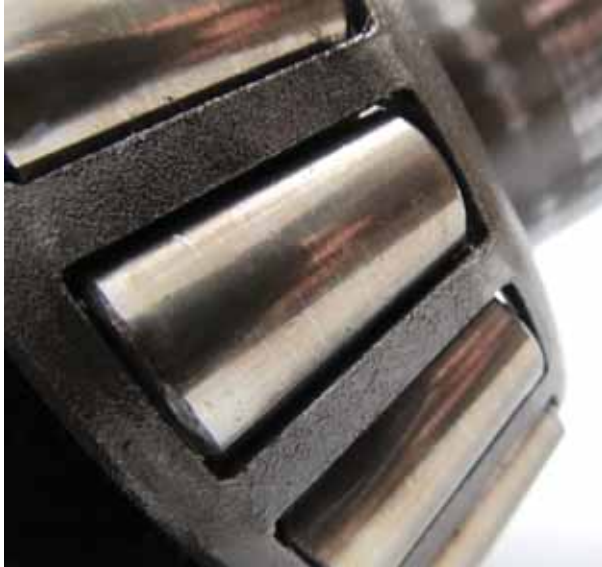
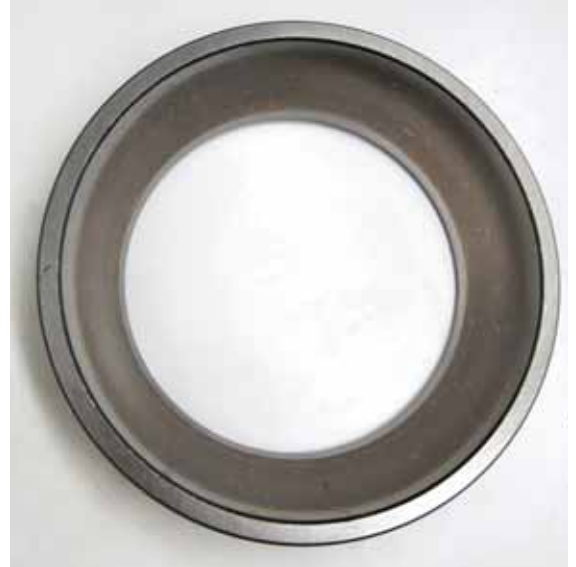
Rear Axle Pinion Bearing

Condition	Cup	Rollers
Wear	8	8
Scoring	10	10
Pitting	8 ¹	8 ¹
Spalling	10	10
Discoloration	7	7
Corrosion	10	10
Roller End Wear	NR	7

¹Debris denting, not pitting

The rear axle pinion bearing received excellent protection, earning perfect 10 merit ratings for scoring, spalling and corrosion. Despite elevated heat and rotational stress, pitting and wear were limited to *trace-light* levels, confirming the lubricant maintained protection throughout the service interval.

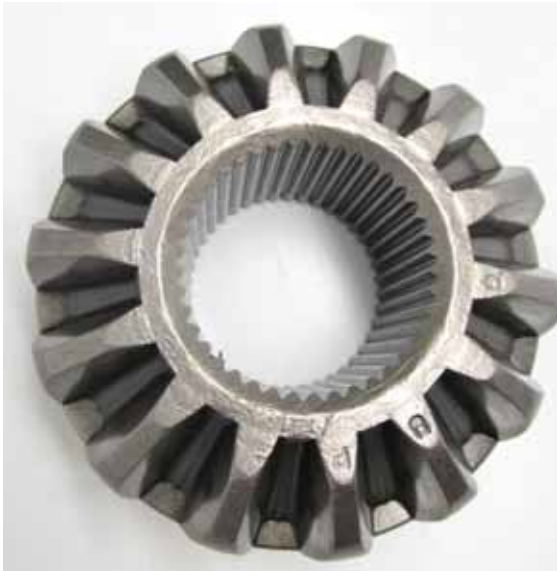
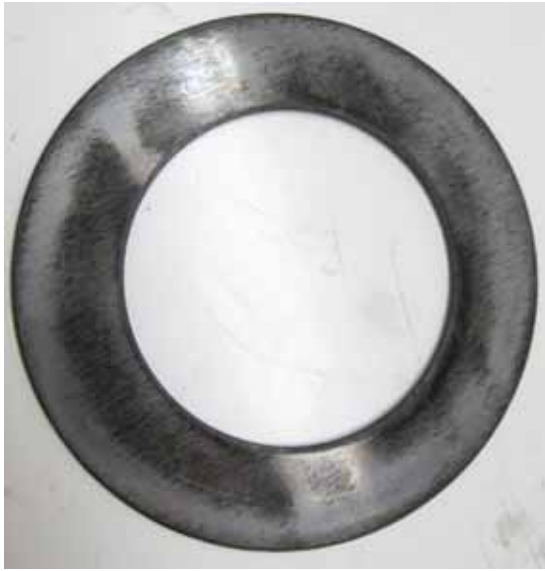
Rear Axle Side Gear & Thrust Washer

Condition	Side Gear	Thrust Washer
Burnish	Bright	NR
Wear	7	8
Rippling	10	NR
Ridging	10	NR
Pitting	10	NR
Spalling	10	NR
Scoring	10	NR
Discoloration	9	9
Corrosion	10	NR

The rear axle side gear received perfect 10 merit ratings in six of eight applicable categories, indicating the high level of protection the lubricant provided. Wear was controlled to a *light* level. The thrust washer exhibited *trace-light* wear, confirming the protection provided by the lubricant.
